Fire Resistant Retrofit Assembly

FIRE RESISTANT RETROFIT ASSEMBLY

Project Number 2024-009
Project Name HIGH PERFORMANCE WALL ASSEMBLY

ALBERTA ECOTRUST FOUNDATION

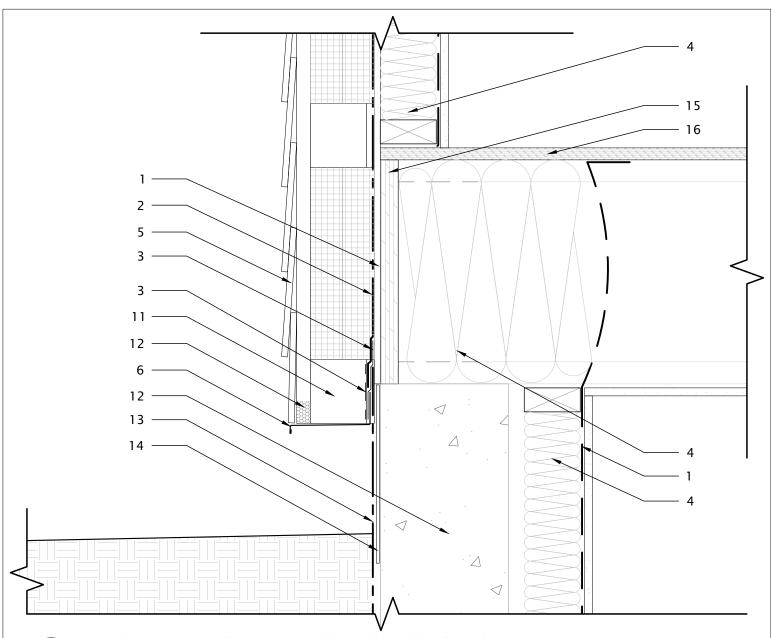
FOUNDATION TRANSITION SECTION DETAIL

1 VAPOUR BARRIER

2 AIRTIGHT WATER RESISTANT

3 SELF ADHERED MEMBRANE

4 EXISTING FIBREGLASS BATT INSULATION

5 CLADDING

6 FLASHING

12 CONCRETE FOUNDATION

13 DAMPPROOFING

14 PARGING

15 RIM BOARD

16 SUBFLOOR

17 THERMALLY BROKEN Z GIRT

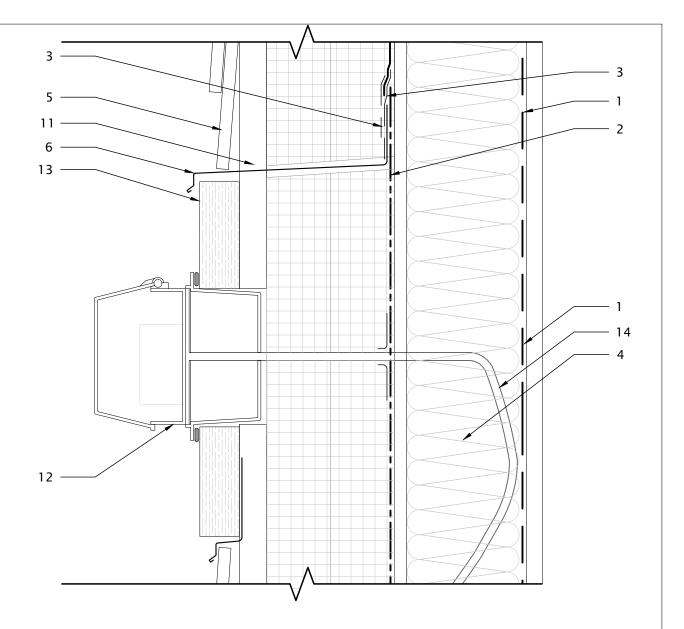
RECEPTACLE SECTION DETAIL

1 VAPOUR BARRIER

2 AIRTIGHT WATER RESISTANT

3 SELF ADHERED MEMBRANE

4 EXISTING FIBERGLASS BATT INSULATION

5 CLADDING

12 IN USE RECEPTACLE ASSEMBLY 13 BATTEN

14 ELECTRICAL WIRE

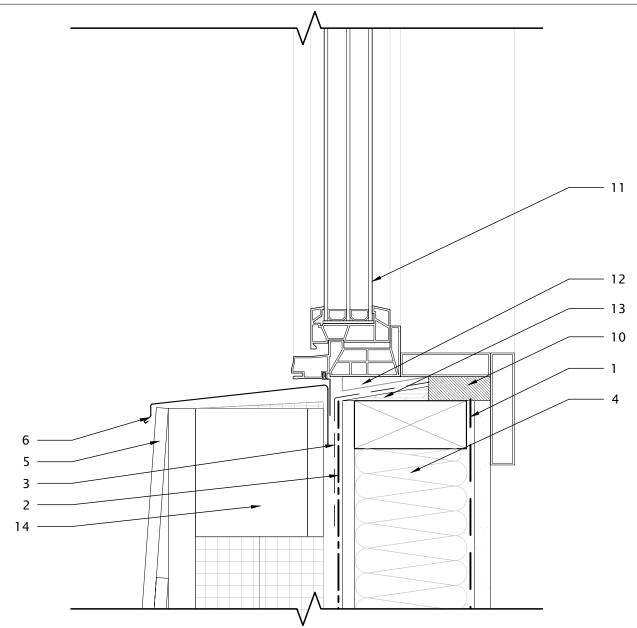
WINDOW SILL SECTION DETAIL

1 VAPOUR BARRIER

2 AIRTIGHT WATER RESISTANT

3 SELF ADHERED MEMBRANE

4 EXISTING FIBERGLASS BATT INSULATION

5 CLADDING

6 FLASHING

12 WINDOW SUPPORT SHIM 13 BEVELED SIDING SLOPED DAM 14 THERMALLY BROKEN Z GIRT **SYSTEM**

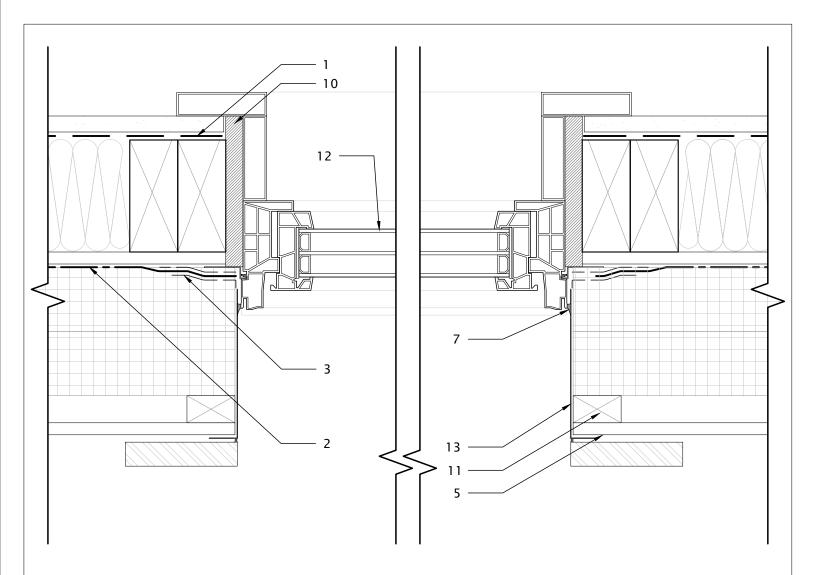
WINDOW JAMB PLAN DETAIL

1 VAPOUR BARRIER

11 RAINSCREEN STRAPPING

12 GLAZING UNIT 13 CLOSURE FLASHING

2 AIRTIGHT WATER RESISTANT

- 3 SELF ADHERED MEMBRANE
- 4 EXISTING FIBREGLASS BATT INSULATION
- **5 CLADDING**
- 6 FLASHING
- 7 SEALANT
- **8 NON-HARDENING SEALANT**
- 9 COMPRESSED FOAM ROD
- 10 EXPANDING POLYURETHANE SPRAY FOAM

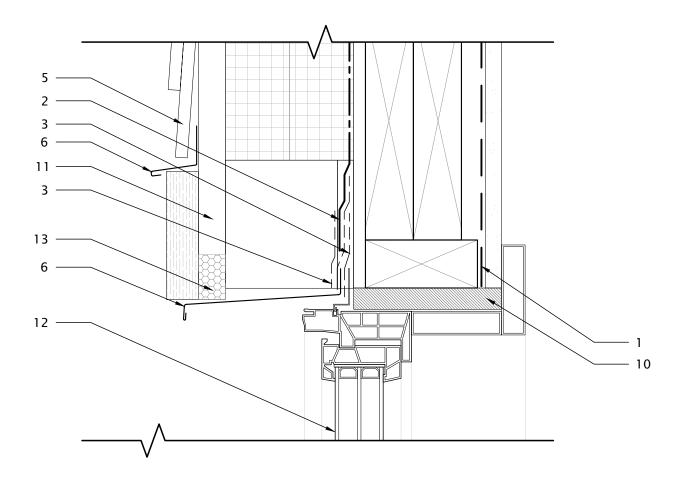
WINDOW HEAD SECTION DETAIL

1 VAPOUR BARRIER

11 RAINSCREEN STRAPPING

12 GLAZING UNIT 13 BUG SCREEN

2 AIRTIGHT WATER RESISTANT

3 SELF ADHERED MEMBRANE

4 EXISTING FIBREGLASS BATT INSULATION

5 CLADDING

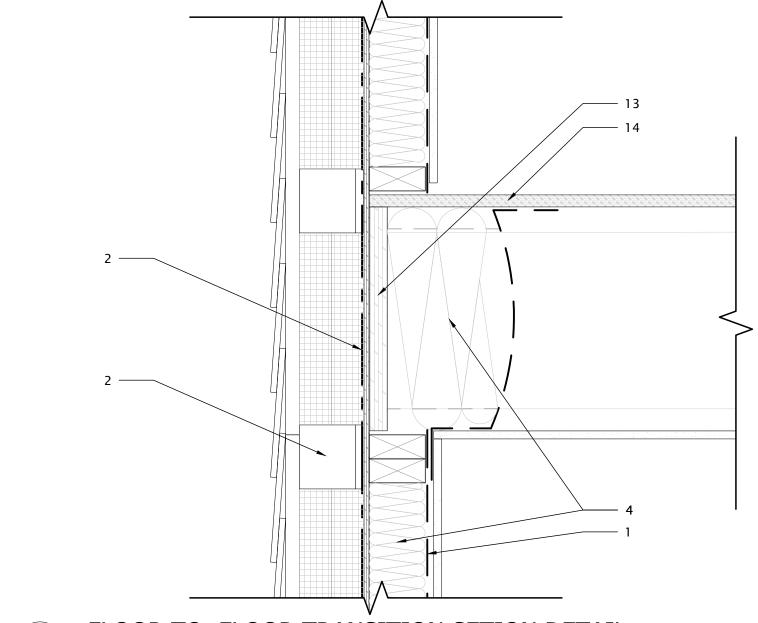
FLOOR TO FLOOR TRANSITION SETION DETAIL

11 RAINSCREEN STRAPPING

12 THERMALLY BROKEN Z GIRT

1 VAPOUR BARRIER

2 AIRTIGHT WATER RESISTANT BARRIER

3 SELF ADHERED MEMBRANE

4 EXISTING FIBREGLASS BATT INSULATION

5 CLADDING

12 RIM BOARD

13 SUBFLOOR

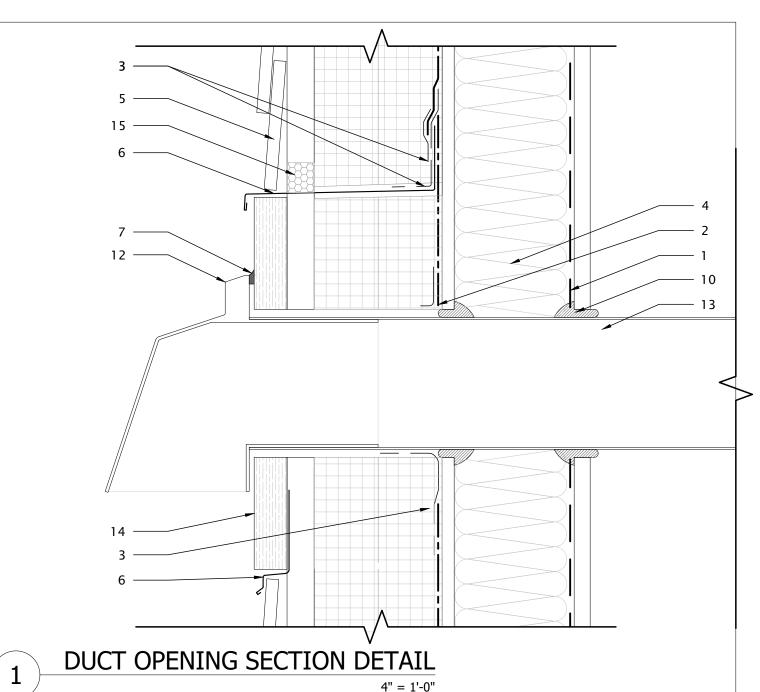
1 VAPOUR BARRIER

11 RAINSCREEN STRAPPING

12 DUCT HOOD

13 DUCT 14 BATTEN

15 BUG SCREEN

2 AIRTIGHT WATER RESISTANT

4 EXISTING FIBREGLASS BATT INSULATION

5 CLADDING

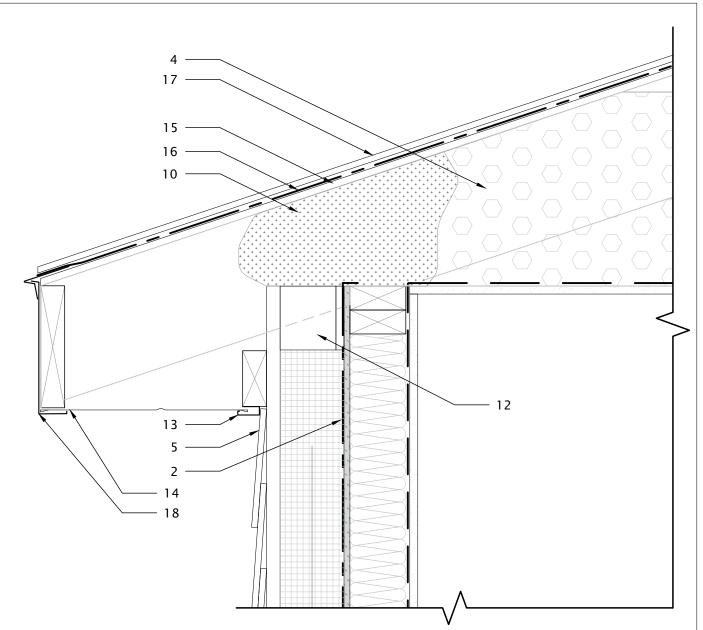
WALL TO ROOF TRANSITION SECTION DETAIL

1 VAPOUR BARRIER

2 AIRTIGHT WATER RESISTANT **BARRIER**

3 SELF ADHERED MEMBRANE

4 EXISTING ATTIC INSULATION

5 CLADDING

13 J-CHANNEL 11 RAINSCREEN STRAPPING

12 THERMALLY BROKEN Z **GIRT SYSTEM**

14 SOFFIT

15 ROOFING SHEATHING

16 ROOFING MEMBRANE

17 ROOFING SHINGLE

18 FASCIA

- Taping to seal all joints and openings in the WRB.
- Installation of closed cell spray foam insulation at the wall to rafter connection, sealing WRB to ceiling poly.
- Seal WRB to foundation with a sealant that works with the membrane and concrete.
- Taping electrical wire penetrations.
- Taping WRB to window frame on the sides and the top.
- Taping WRB to mechanical penetrations
- Foam backer rod and caulking to connect the window frame sill to the WRB at the sill.

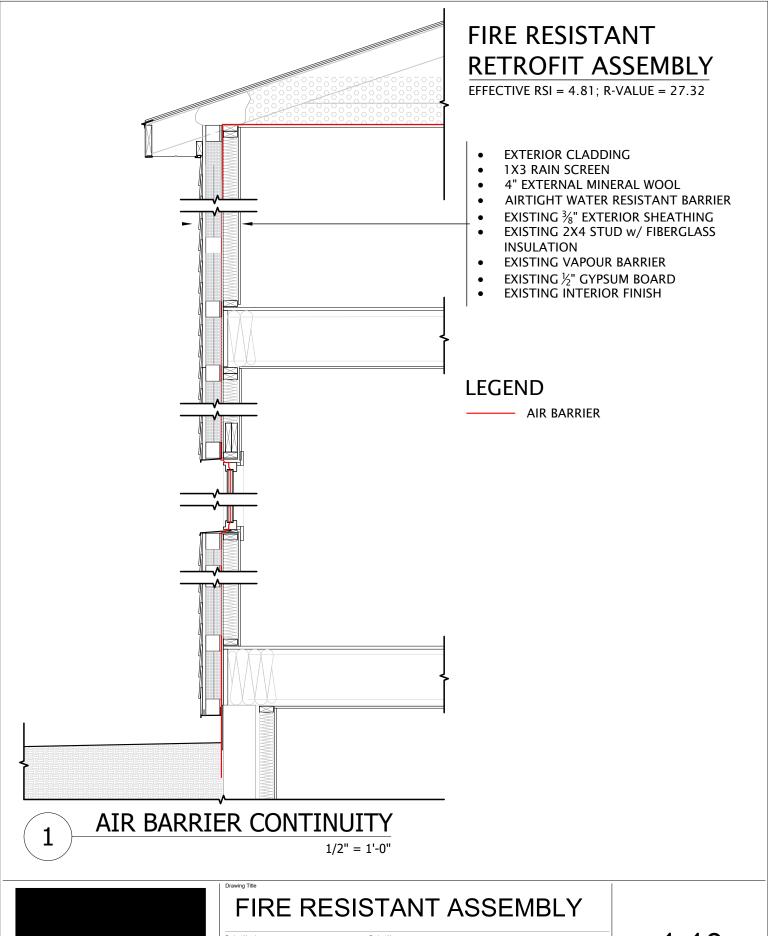
1.09 1.08 1 1.07 1.06 1.05 1.04 1.03 1 1.02 **ENVELOPE SECTION** 1/2" = 1'-0"

EFFECTIVE RSI = 4.81; R-VALUE = 27.32

- EXTERIOR CLADDING
- 1X3 RAIN SCREEN
- 4" EXTERNAL MINERAL WOOL
- AIRTIGHT WATER RESISTANT BARRIER
- EXISTING 3/8" EXTERIOR SHEATHING
- EXISTING 2X4 STUD w/ FIBERGLASS INSULATION
- EXISTING VAPOUR BARRIER
- EXISTING ½" GYPSUM BOARD
- EXISTING INTERIOR FINISH
