### Exterior Mineral Wool Tier 3 Assembly

Exterior Mineral Wool Tier 3 Assembly **Construction Details**

Project Number
 2024-009
 Project Name
 HIGH PERFORMANCE WALL ASSEMBLY

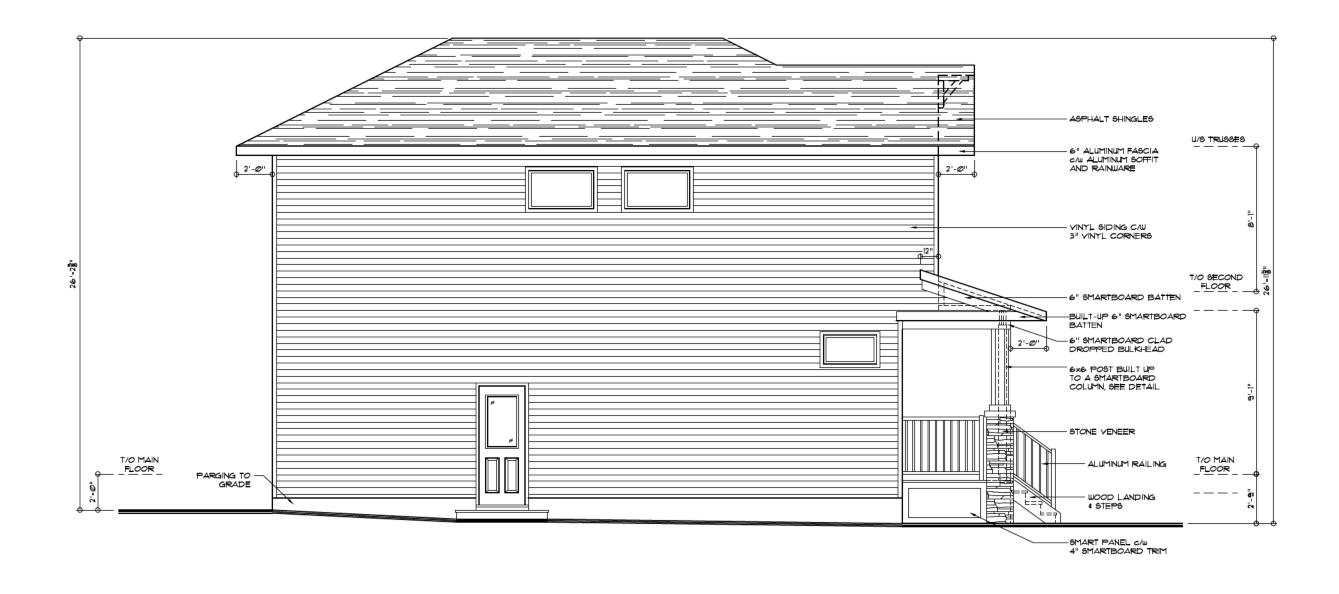
LIMITING DISTANCE:
ALLOWABLE OPENINGS;
EXPOSED BUILDING FACE:
UNPROTECTED OPENINGS;
ACTUAL OPENINGS;

3,08 m 9,00 % 143,33 sq.ft. 46,84 sq.ft. 6,30%
