Case Study

Valleyview Town Hall
Valleyview, Alberta

Background

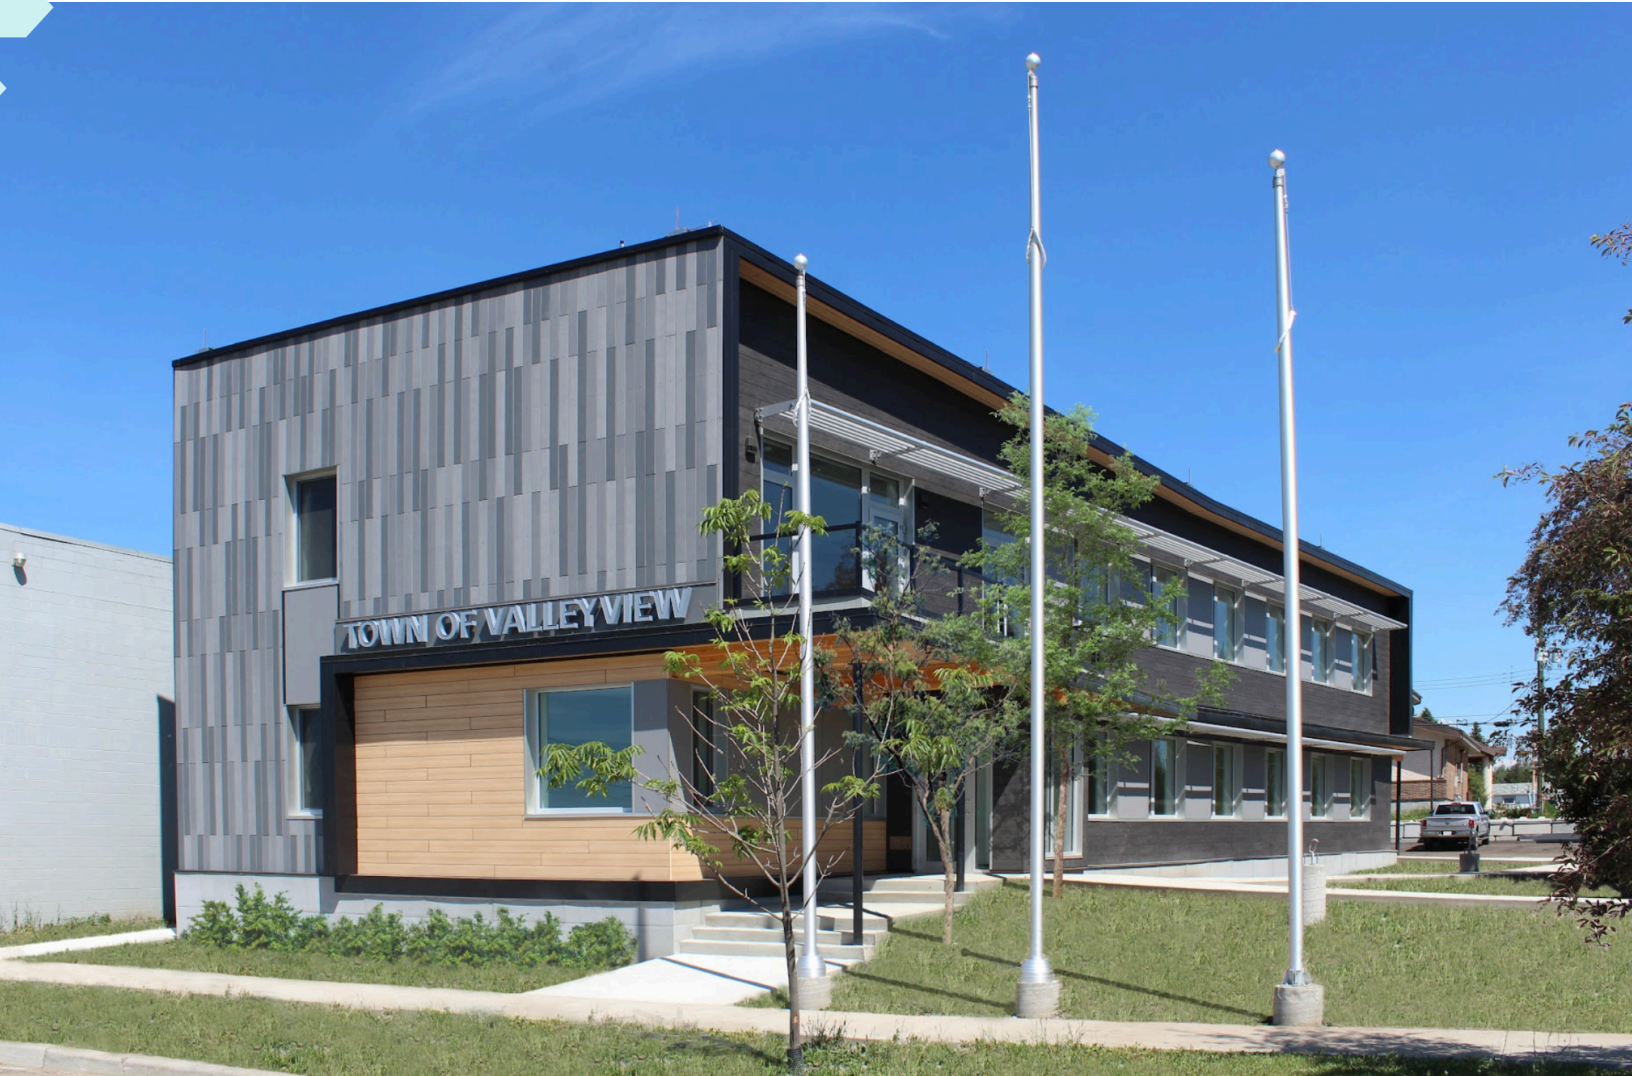
Exterior front view of the municipal building

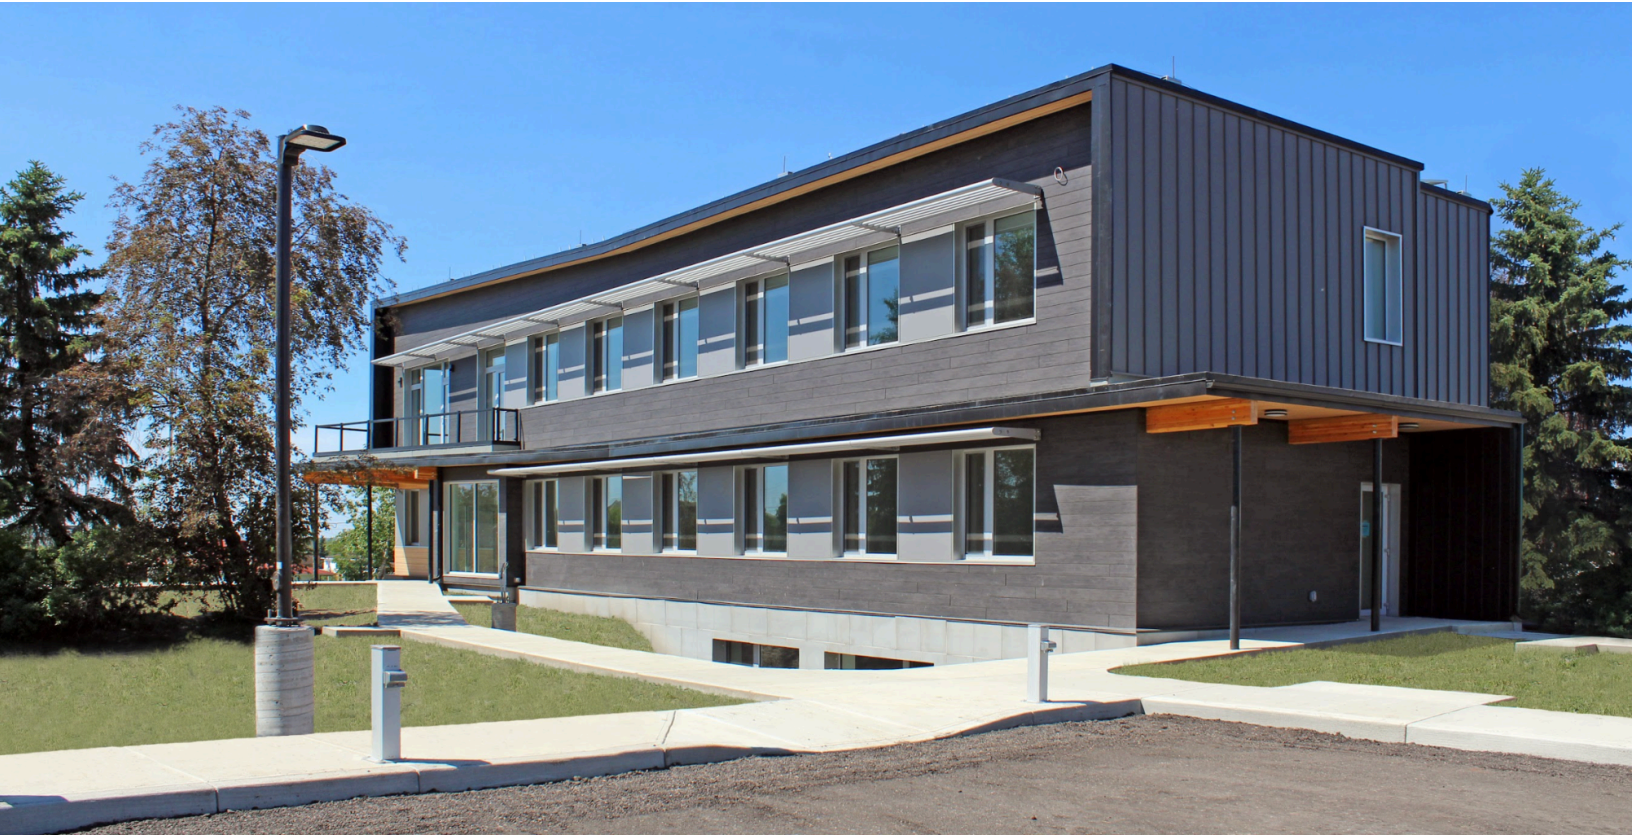
Exterior view of the back south side of the building

Solar orientation was an important consideration in this northern climate. The building’s layout has working areas along the south-facing facade, where exterior shading (fixed to the building) helps shade the sun in the summer while allowing for passive heating in winter.

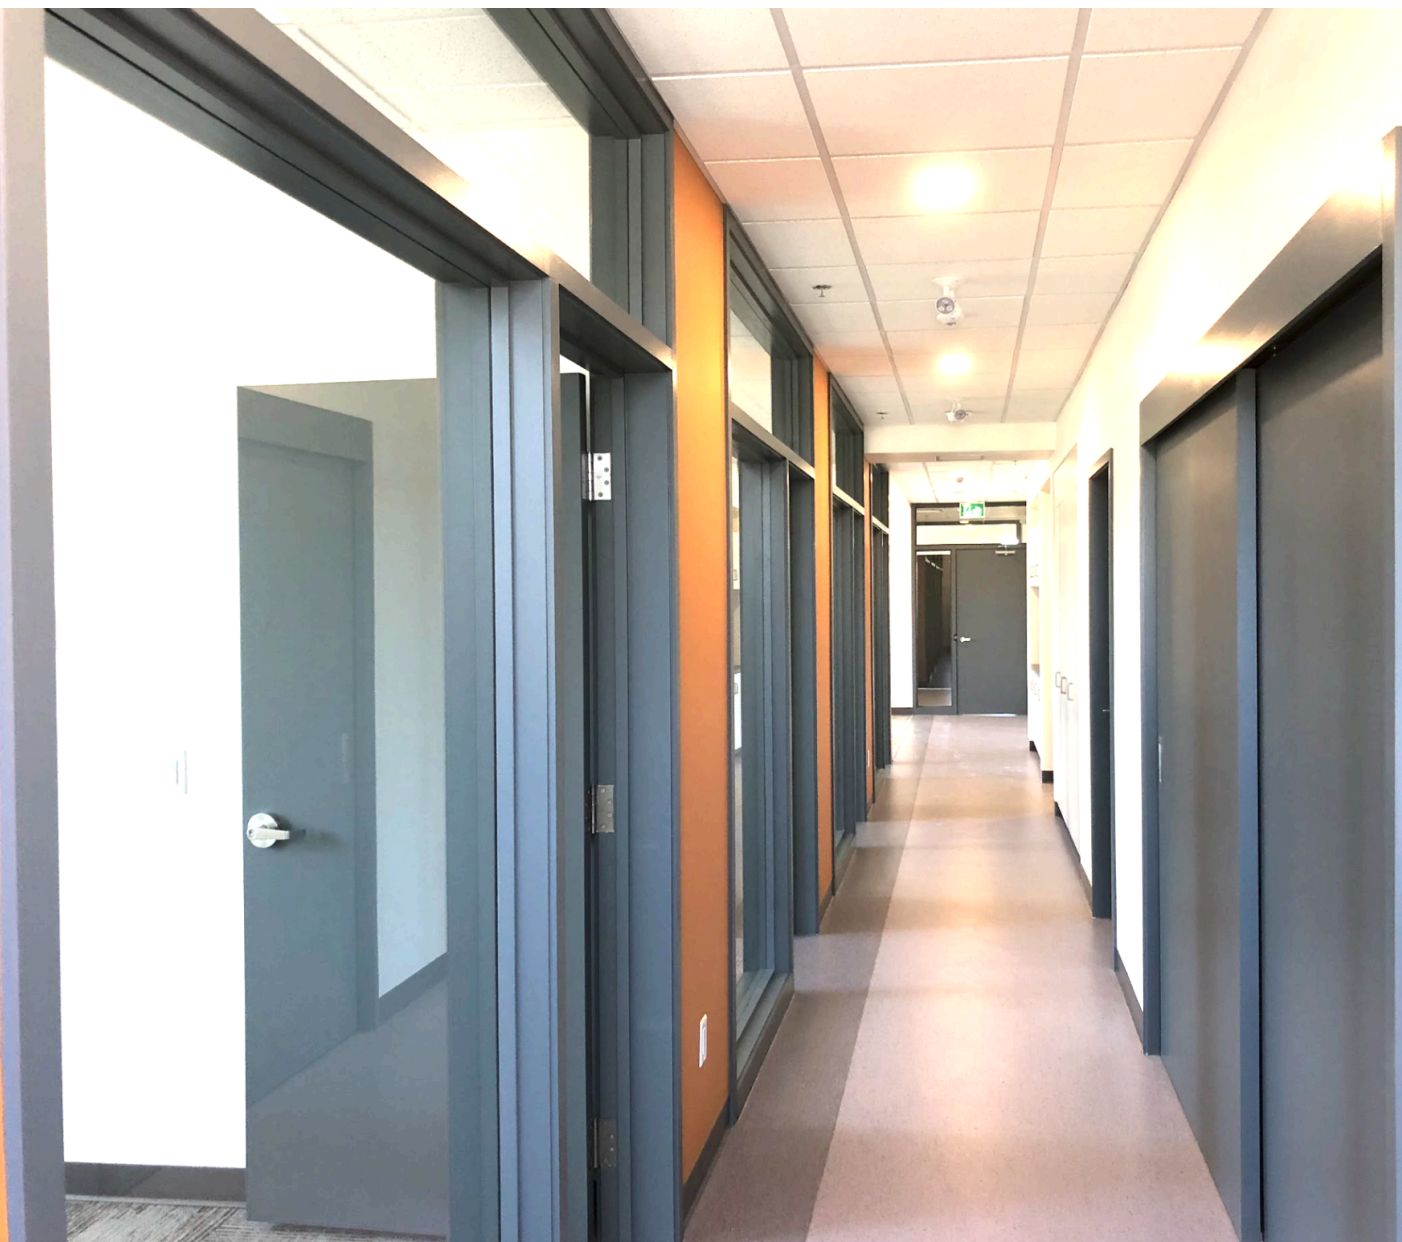
Interior view of the modern, well-lit hallway with offices

Recognizing the importance of psychological well-being, workspaces are positioned next to operable windows with views of the adjacent park. Outdoor spaces, including a balcony and seating area, support a strong visual and physical connection to nature.
